Breakout D: Drought Planning & Operational Readiness

CITY OF BELMONT'S PUBLIC WATER INTAKE Catawba River excavation project

BACKGROUND, PLANS, NEXT STEPS

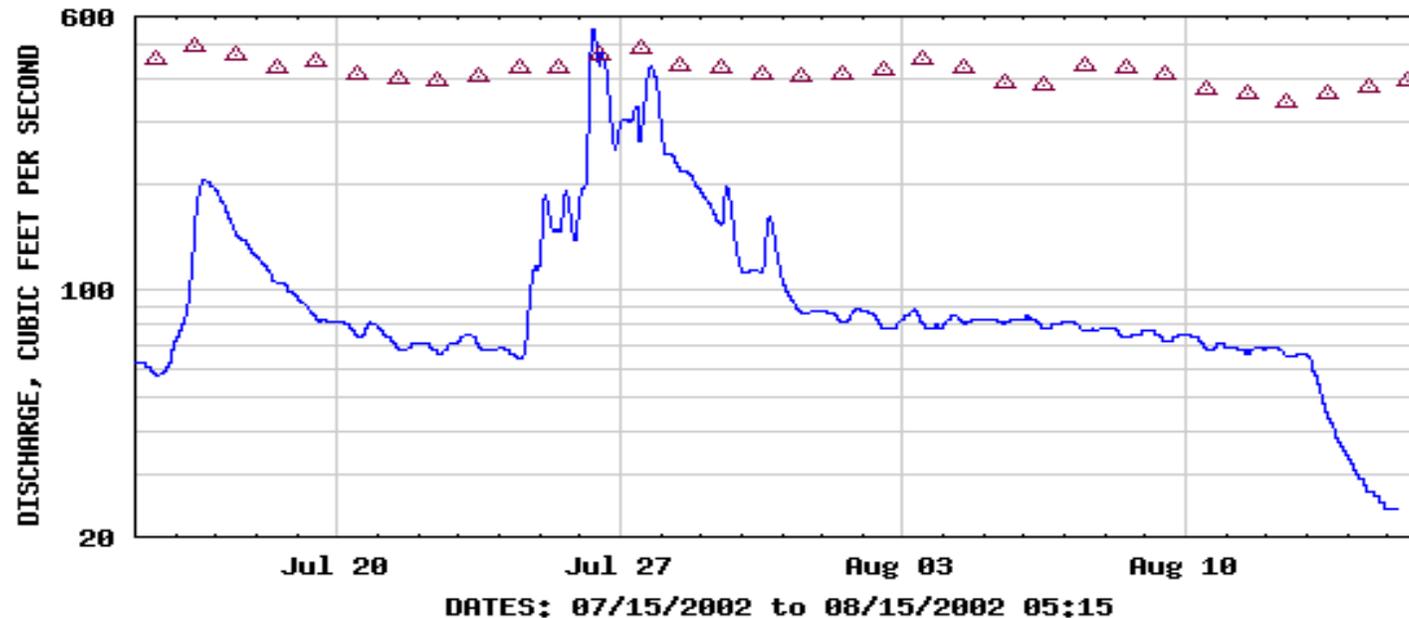
USGS 02145000 SOUTH FORK CATAWBA RIVER AT LOWELL, NC

EXPLANATION

— DISCHARGE

△ MEDIAN DAILY STREAMFLOW BASED ON 47 YEARS OF RECORD

The South Fork River had Dried Up

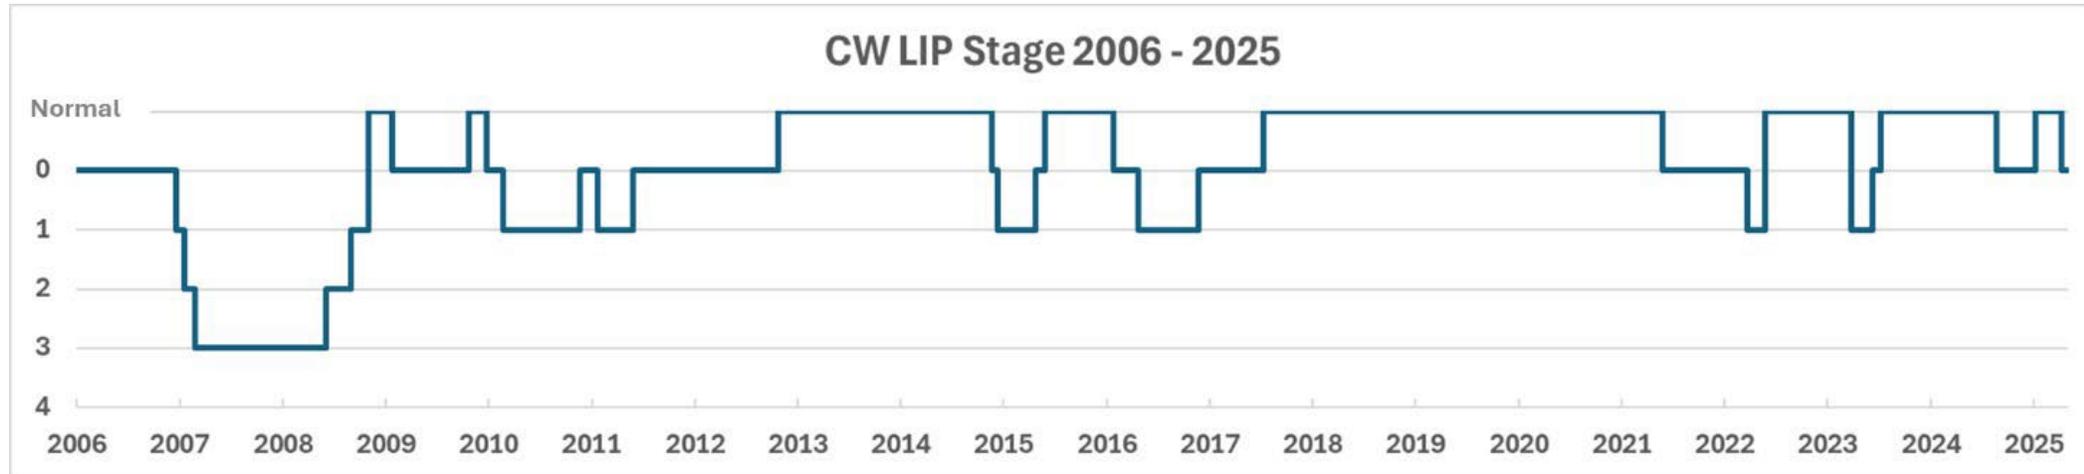
First 19 Years of Operation with an LIP

- LIP has been initiated regularly over the past two decades
- Water Use Restrictions – Stage 0 (none), Stage 1 (Voluntary), Stages 2 & 3 (Mandatory), Stage 4 (Emergency)
- LIP is constantly reviewed and monitored for enhancement, last updated in 2022
- Modeling the LIP consistently demonstrates it extends water accessibility by decades through its water use reductions and operational modifications

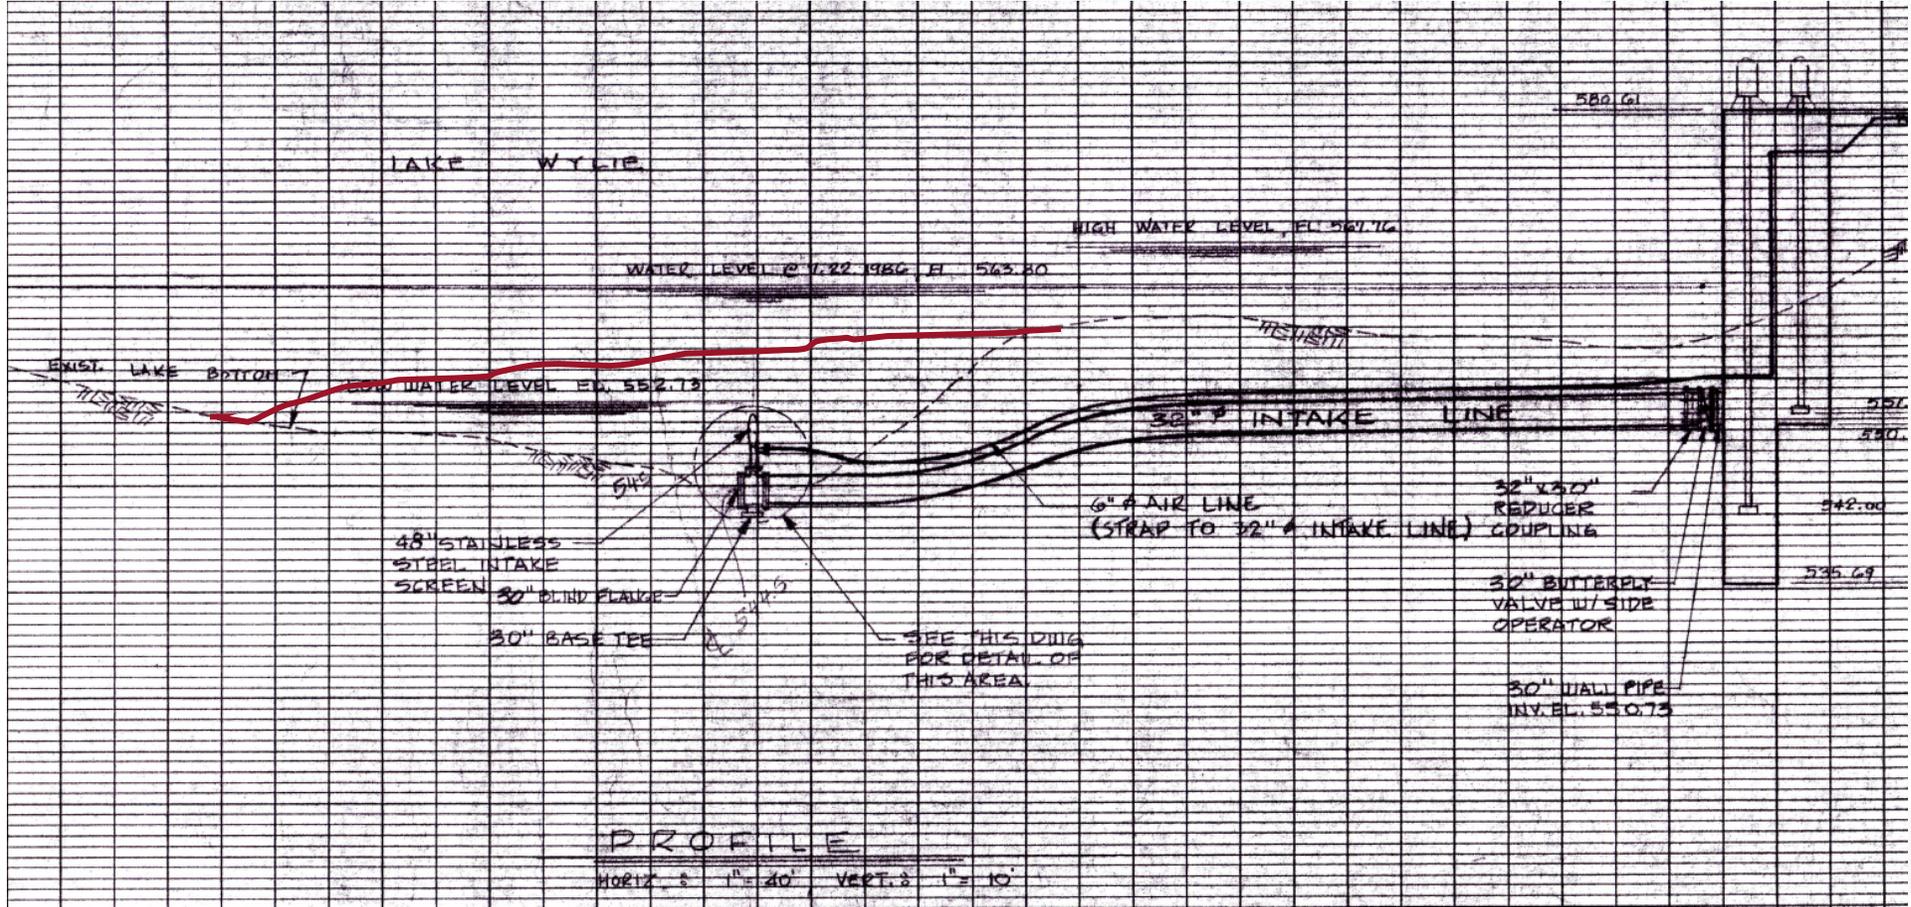
Water intake pump house

- Constructed in 1950s without the intake pipe
- Houses raw water pumps
- Currently intaking water through sluice gates not through the submerged intake pipe

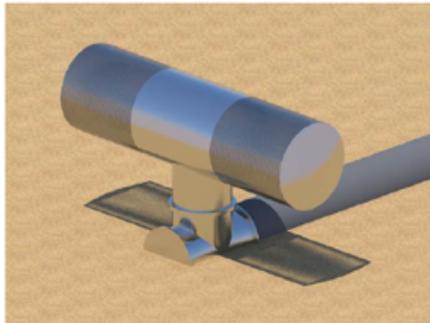
Image 2 - 3D image of 48" raw water intake screen

Inspected the intake. The screen was visible. Not covered by sediment and no damage or debris was found. Noted there was 1 ft clearance between the intake screen and the river bottom. Below is a rendering of the intake screen in the inspection report.

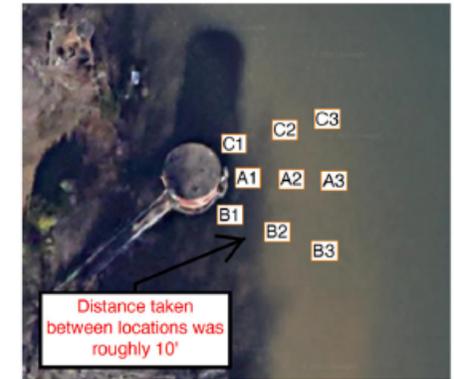
Figure-1 Inspection Locations

Dive Inspection done for sediment depth study of the area surrounding the pumphouse so we could plan for sluice gate repair/replacement.

Table 1 Inspection Data

Location:	Depth of Water:	Probe Depth:
A1	6'	6'
A2	7'	5.5'
A3	8'	6'
B1	5'	4.5'
B2	7'	7'
B3	8'	8'
C1	6'	5.5
C2	6'	4'
C3	4'	5'
Sluice Gate	6'	4'

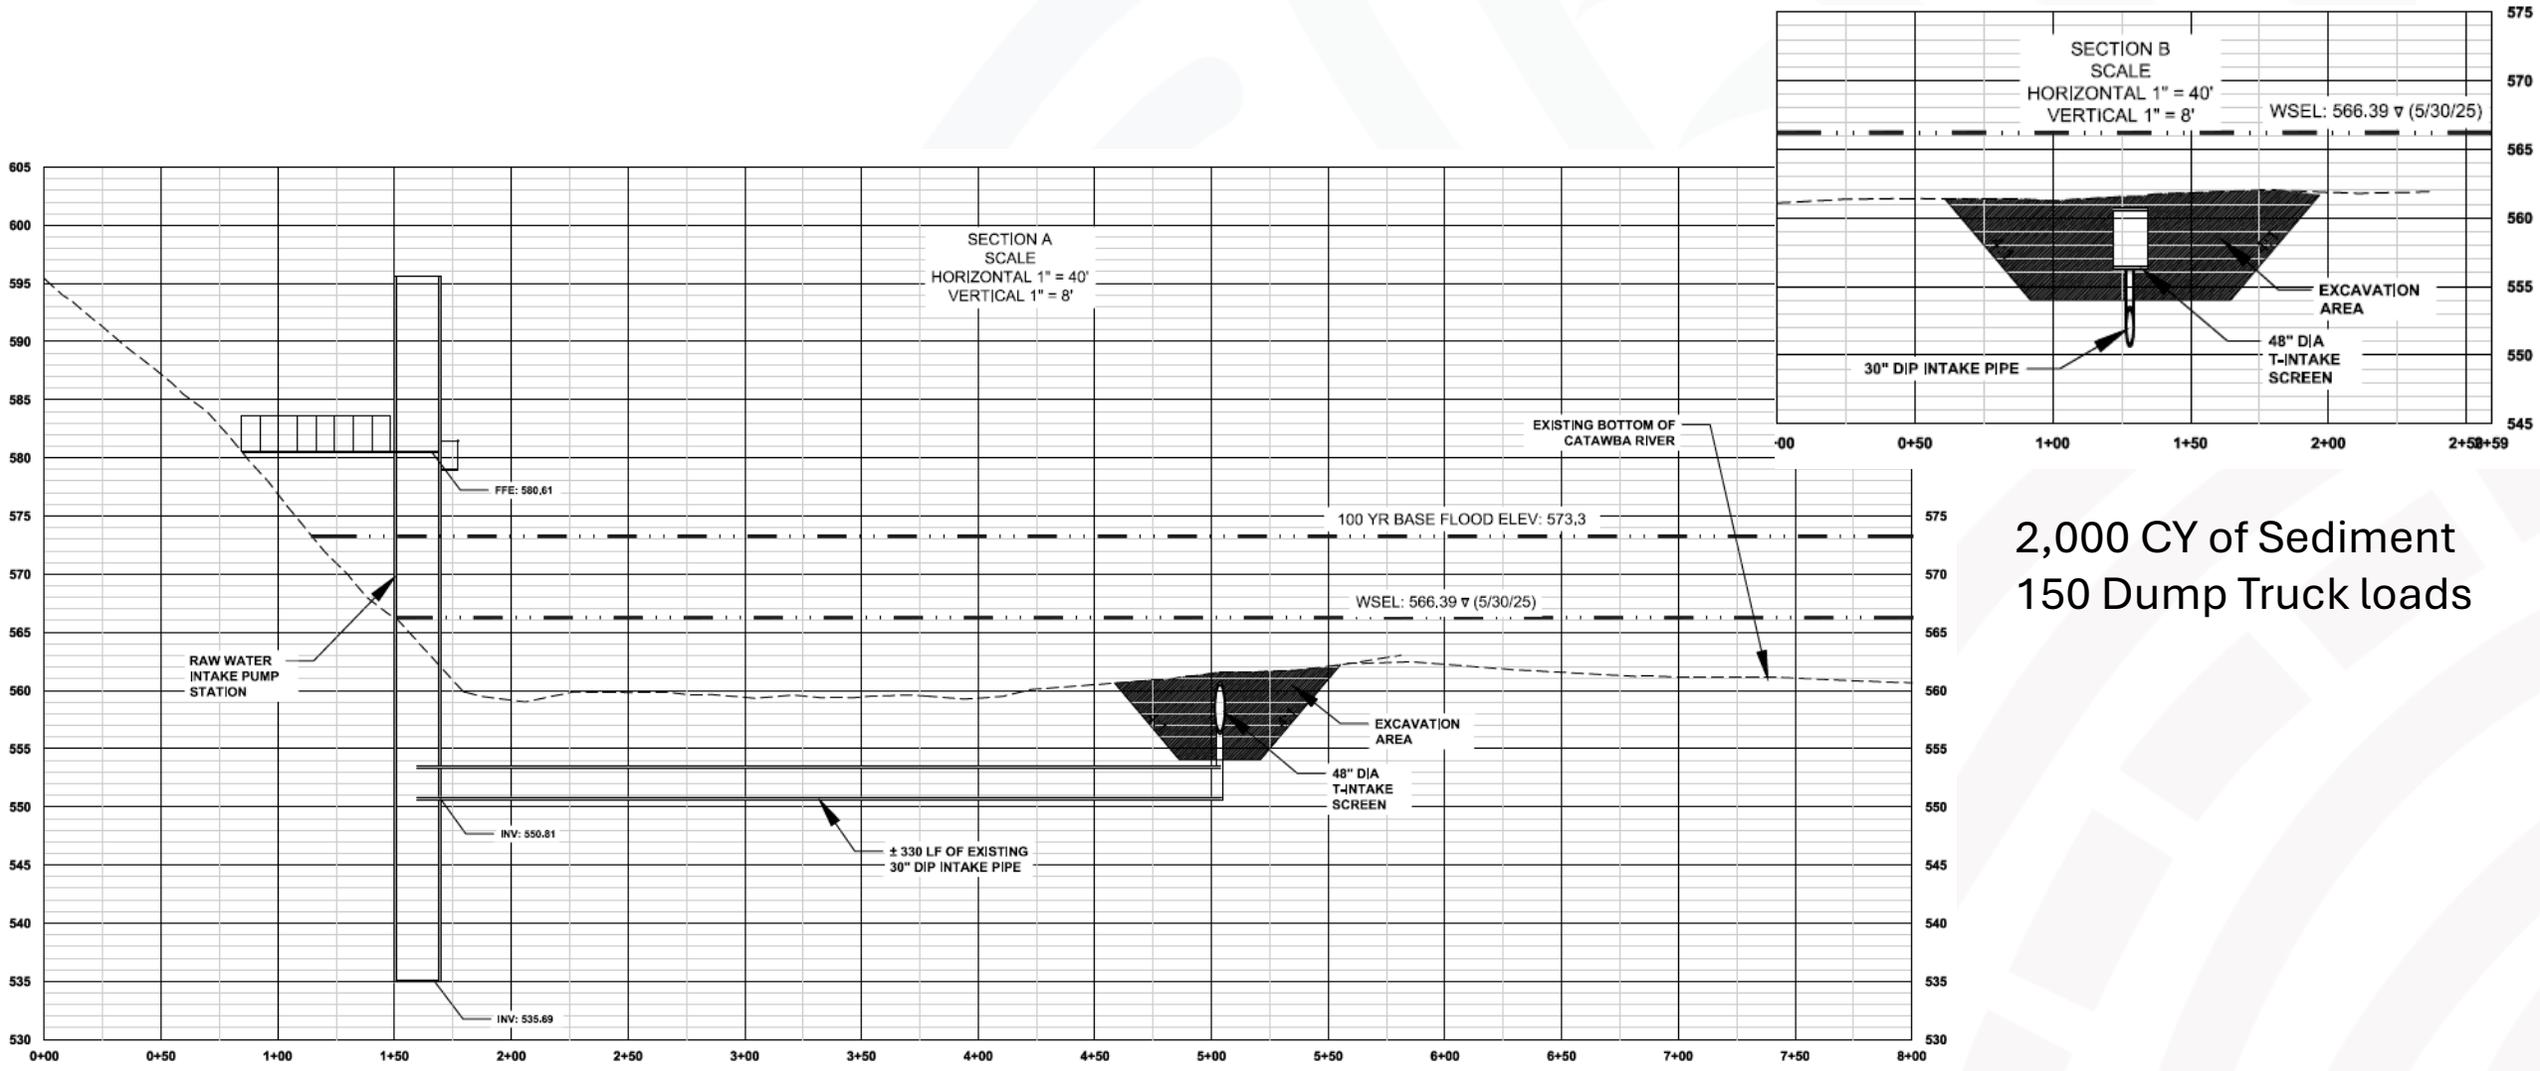
Current excavation project on intake

2,000 CY of Sediment
150 Dump Truck loads

- The City of Belmont conducted its own survey to estimate the amount of sediment that needs to be removed.
- Water depths were measured in strategic locations around the intake screen and along the intake pipe.
- GIS coordinates were assigned to each depth measurement using an ESRI field map app.
- GPS points were transferred into AutoCAD with the corresponding depths and a 3D surface drawing was created.

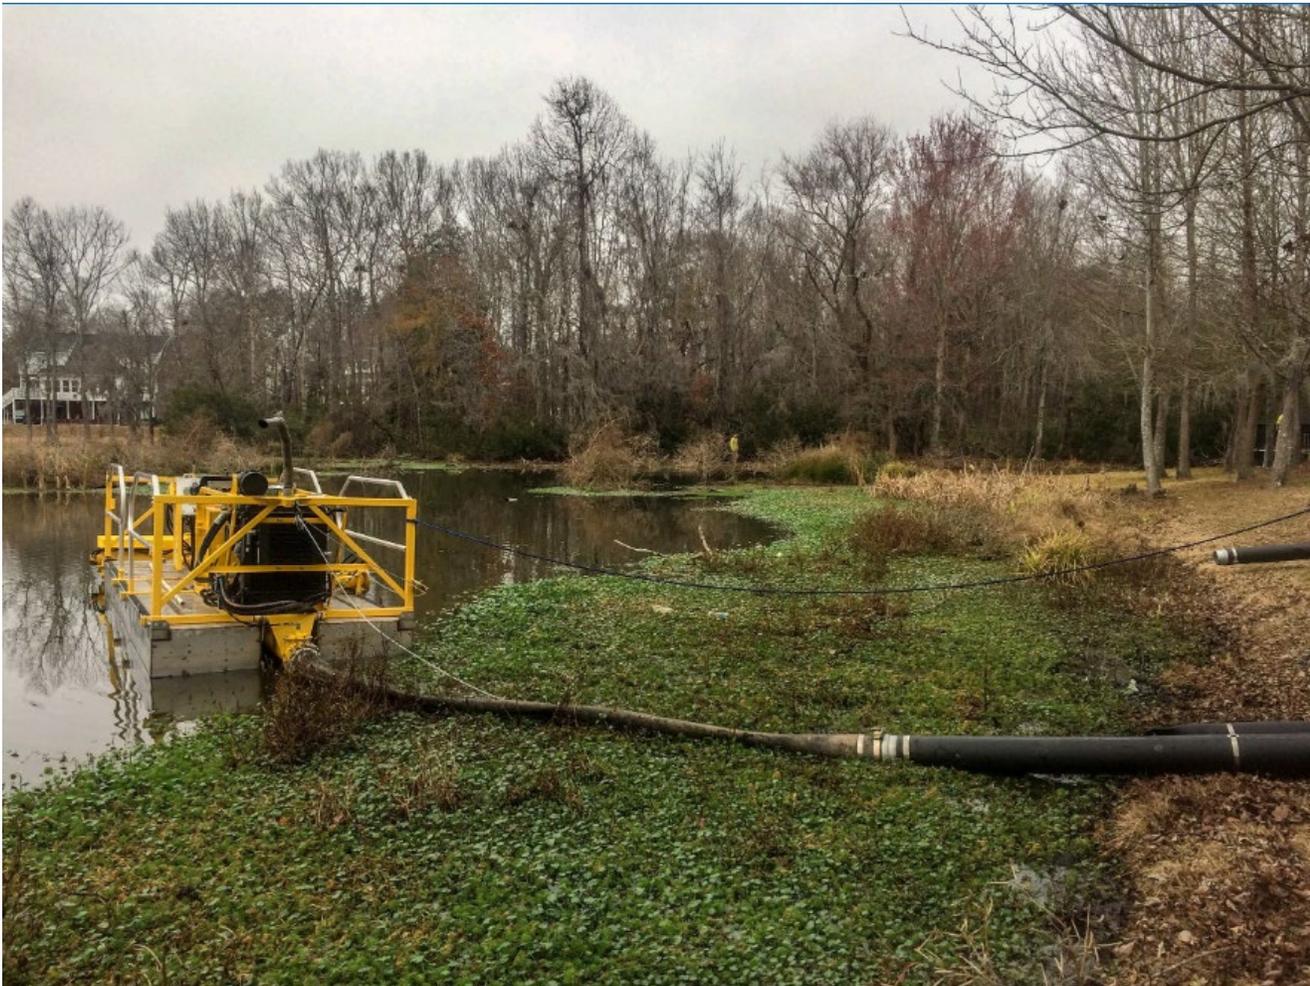
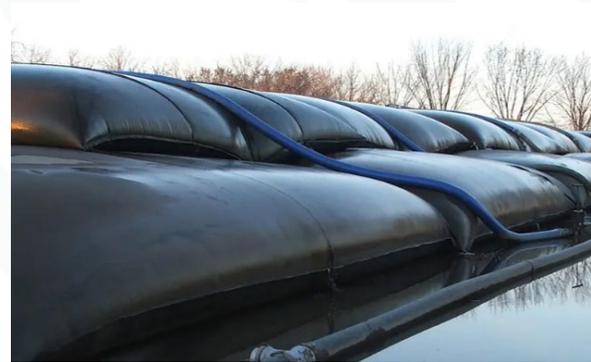
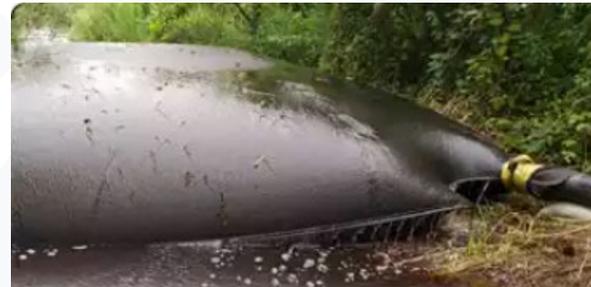
Dewatering Bags

Dewatering bags separate water from sediment in a compact footprint. Crews connect the discharge line set the bag on a prepared pad and allow the fabric to hold solids while clear water returns to the site. Bags swap quickly so flow keeps moving and small jobsites can continue to dewater.

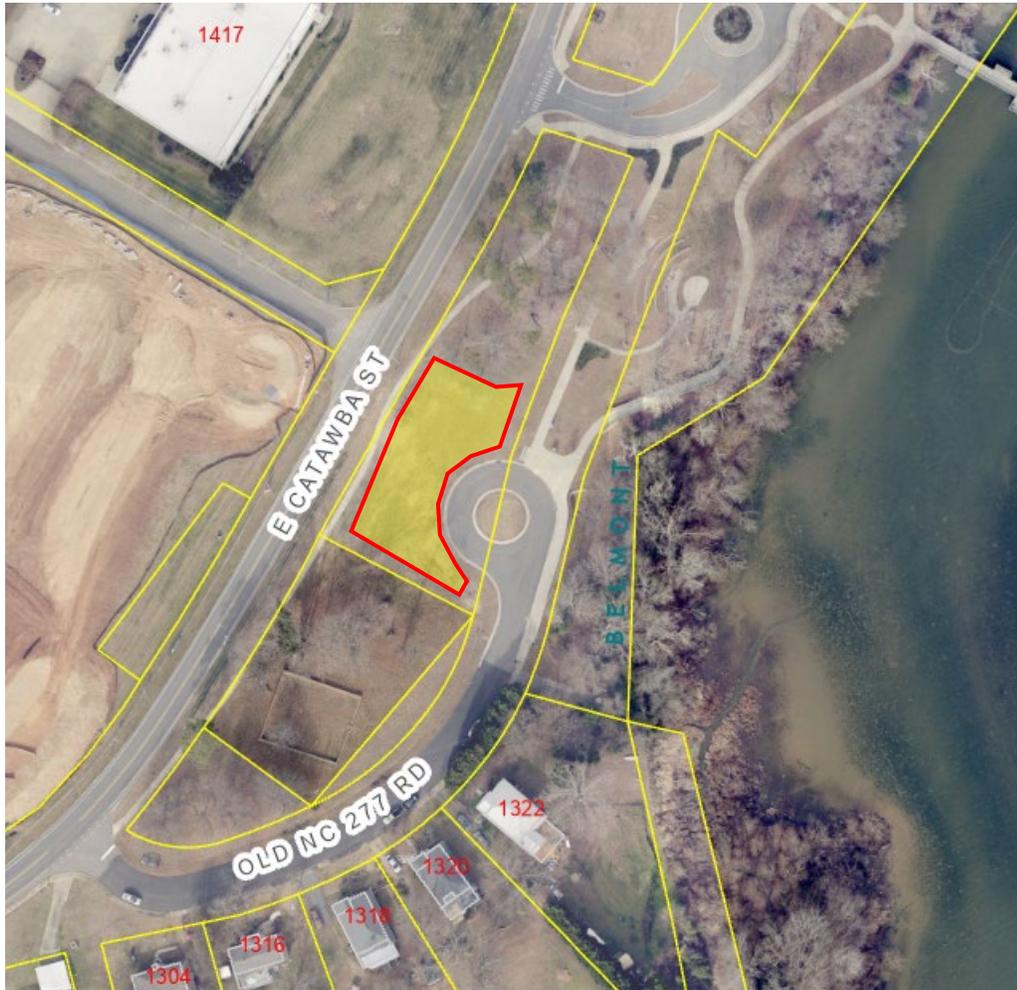
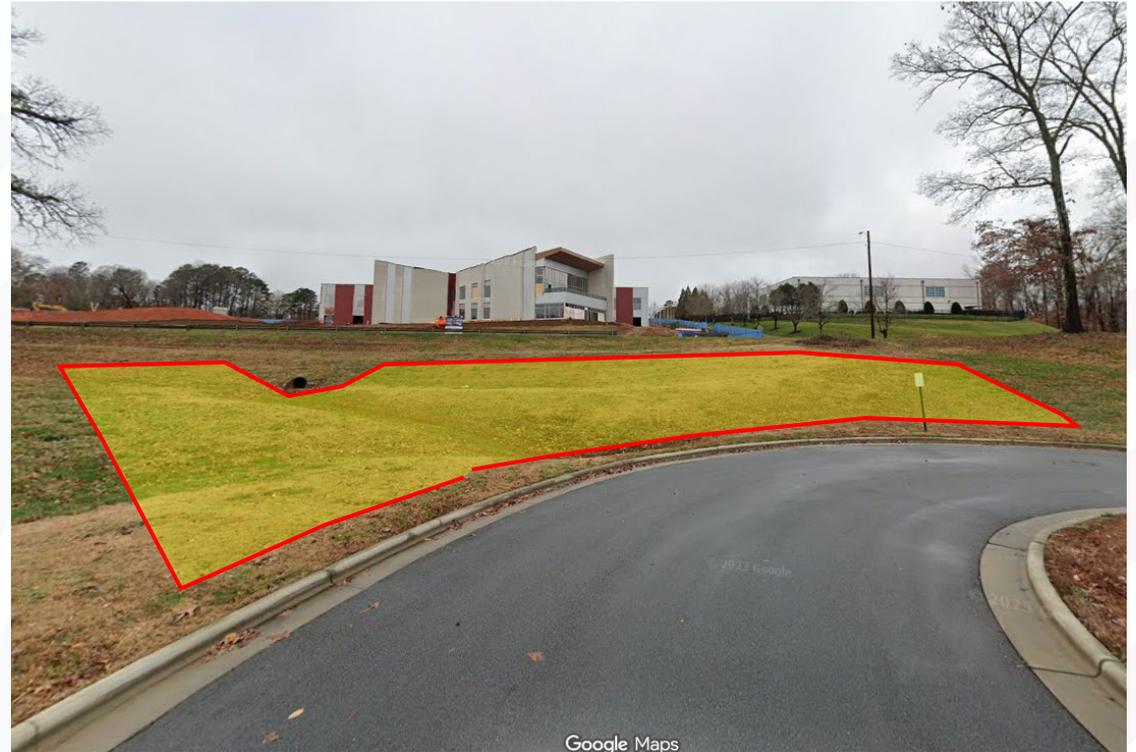
Spoil Site Selection

- City owned property would be ideal because this is a long-term project.
- Dewatering bags must be 50 ft from shore on all sides.
- Ease of running barge or equipment from dredge site to spoil site.
- Clearance of vegetation and restrictions for preserving riparian buffers.
- Ease of access of dump trucks that will be transporting sediment.
- Consider disturbance the dump trucks will have on traffic and nearby residents.
